## CHAPTER FOUR: THUNDER BAY RIVER PHASE TWO NONPOINT SOURCE INVENTORY

### STREAMBANK EROSION INVENTORY

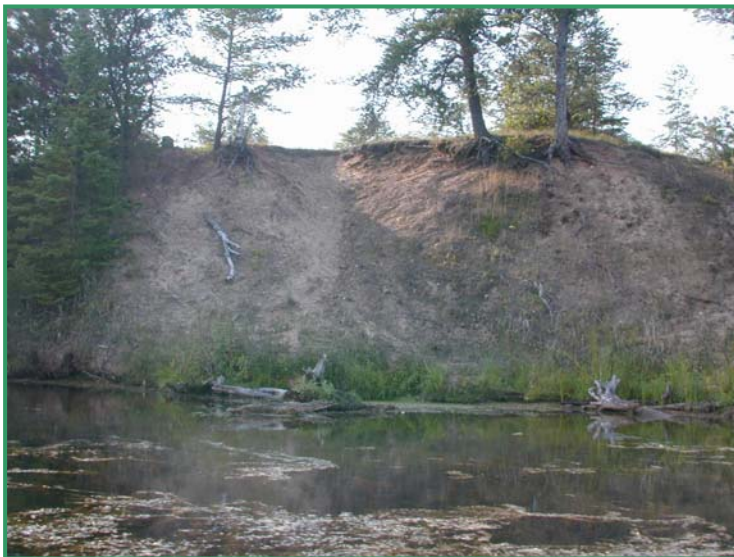
An inventory of streambank erosion sites was conducted in summer 2003. The streambanks were inventoried using a variety of methods, including topographical map review, soils studies analysis, and where navigable, various watercraft were used. For the field inventory, each

erosion site was given an identification number, condition of the site was documented, and photographs were taken of the streambank. Information collected at each site included length and slope of the eroded embankment, soil type and amount of vegetation present, the condition of the bank, and the extent and causes of the erosion (**Appendix B** is a sample data collection form; **Appendix C** is the severity scoring sheet used to determine site rank). Using this data, best management practices were then determined for each site inventoried. In order to identify the most critical erosion sites, a ranking system that evaluates the collected data was used, and each erosion site was determined to be either a *Minor*, *Moderate*, or *Severe*

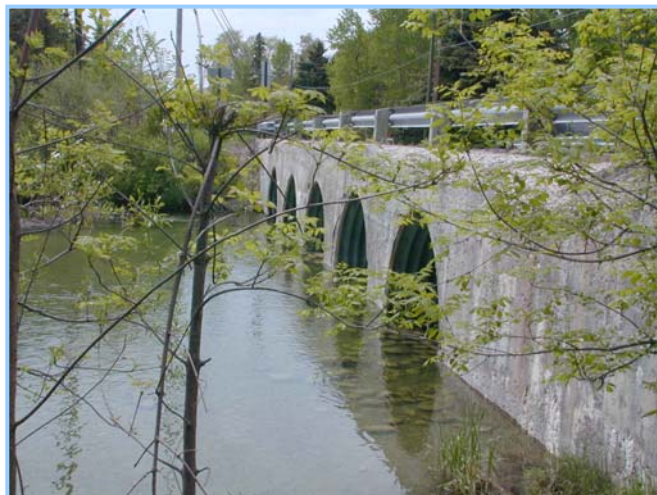
Sediment loading occurs when a net import of sediment exceeds annual export, and the consequences of such loading can be detrimental to the biology and structure of the system. Such a situation can lead to the overall degradation of the system. Sediment loading gradually fills in a stream channel, and under the more stable flow regimes associated with northern Michigan trout streams, the water is most typically displaced laterally. Lateral spread of the channel results in an overall decrease in depth with the variability in depth being nearly eliminated, resulting in a homogeneous stream channel. A change in the stream channel can also result in increased streambank erosion thus compounding the problem. The amount of sedimentation experienced by a waterbody depends on several factors, such as the length and slope of the approaches, steepness of the embankment, whether or not the road is paved, the amount of vegetative cover along shoulders and ditches at the site, and the runoff path.
